ACOUSTIC EMISSION BASED METHOD TO CHARACTERISE THE DAMAGE MODES IN UD THIN CARBON/GLASS HYBRID LAMINATES

Mohamad Fotouhi¹, Putu Suwarta¹, Meisam Jalalvand¹, Gergely Czel^{1,2}, Michael R. Wisnom¹

1. Advanced Composites Centre for Innovation and Science, University of Bristol, Bristol BS8 1TR, UK
2. MTA–BME Research Group for Composite Science and Technology, Budapest University of Technology and Economics, Műegyetem rkp. 3., H-1111 Budapest, Hungary

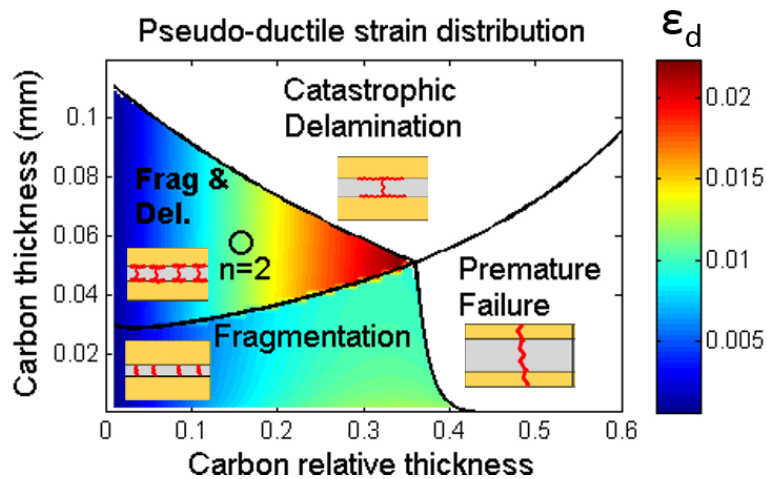
Figure 1. Distribution of pseudo-ductile strain for [G1/C2/G1] laminates made with TR30 carbon.

Since characterization of different damage types was the aim of this paper, the lay-up was chosen to have a combination of damage modes, i.e. both fragmentation in the carbon layer and delamination. Different possible failure modes for different relative and absolute carbon layer thicknesses are illustrated by the damage mode map [3] for S-glass/TR30 hybrids in Figure 1. The damage mode map in Figure 1 shows that $n=2$ for TR30 carbon configurations results in the combined fragmentation and dispersed delamination failure mode.

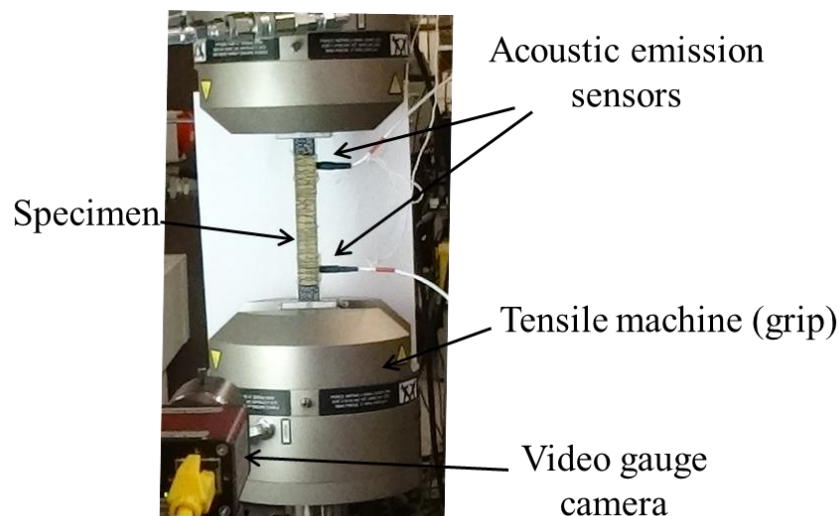
Figure 2. Schematic of the experimental setup.

Tensile testing of the hybrid laminates was executed under uniaxial loading and displacement control using a crosshead speed of 2 mm/min on a computer controlled Instron 8801 type 100 kN rated universal hydraulic test machine with wedge type hydraulic grips (see figure 2). A 25 kN load cell was attached for better resolution in the expected load range. The nominal specimen dimensions for the tests were 240/160/20/h mm overall length/free length/width/variable thickness respectively. 8 specimens were tested. To measure the strains with a nominal gauge length of 130 mm, an Imetrum video gauge system was used, tracking the points applied on the specimen face using points over a particular gauge length. An AE data acquisition system (PAC) PCI-2 with a maximum sampling rate of 40 MHz was used to record the AE signals. Two PAC R15 resonant-type, broadband, single-crystal piezoelectric transducers were used as AE sensors to monitor the damage events. The frequency range of the sensors was 20–900 kHz, and the gain selector of the preamplifier and the threshold value were set to 40 dB. The test sampling rate was 5 MHz.

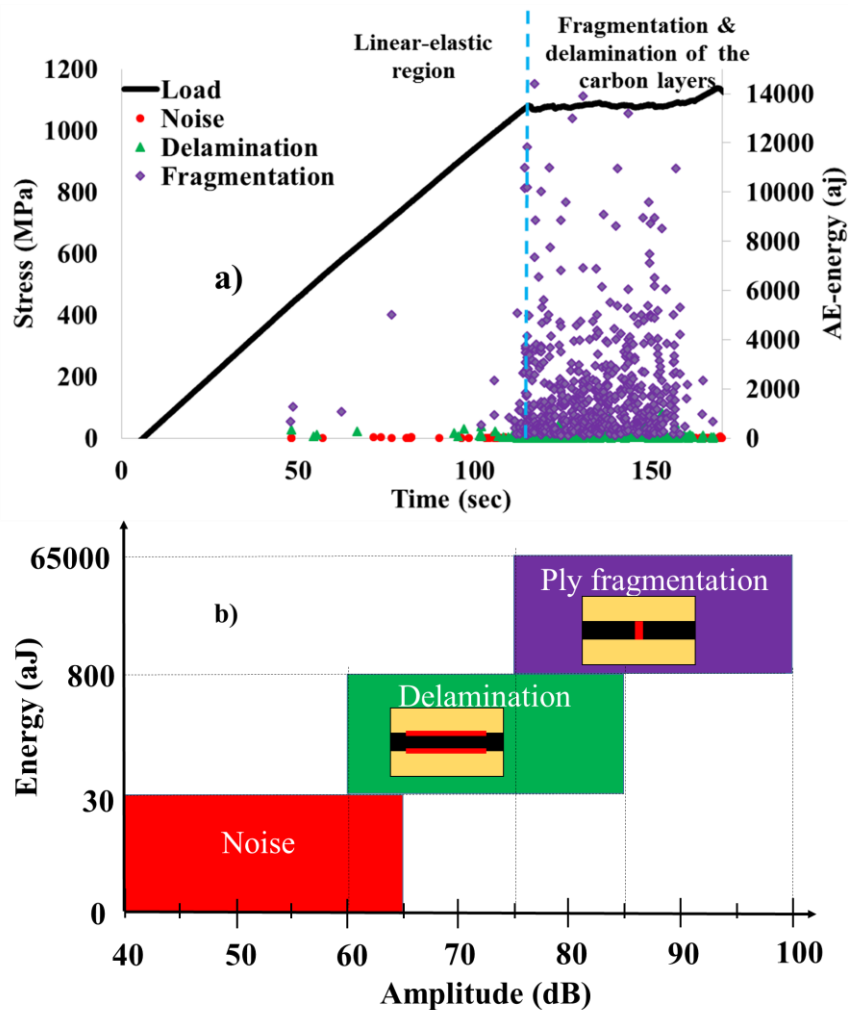
Figure 3. a) Stress-time and AE event energy distribution for a typical TR30/S-glass specimen and b) Event amplitude and energy ranges assigned to different damage mechanisms of ply fragmentation and delamination.

A typical stress-strain plot and its relationship with AE energy are shown in Fig. 3a, for a typical TR30/S-glass hybrid specimen. AE events with different energy levels can be observed for different damage evolution stages in Figure 3a.

In order to identify and separate AE signals originating from the failure modes, AE characteristics of a mode II stable delamination were obtained by producing pure carbon/glass interface delamination. This was done by inserting a pre-cut in the carbon layer [9]. The amplitude of the AE signals was between 60 and 85 dB while the event energy was between 30 and 800 aJ for delamination.

By knowing the characteristics of the AE events corresponding to pure delamination, the obtained AE signals were then classified into two categories with low and high energy and amplitude of the AE signal. Based on our observation, two significant failure modes occurred during the tests. Ply fragmentation was related to the high energy and amplitude range of the AE signals and delamination was associated with the intermediate energy and amplitude range. The ranges of the AE energy and amplitude for the failure modes are indicated in Figure 3b. In addition, there were some weak AE signals from the start of the test with amplitude < 65 dB and energy < 30 aJ which were not related to the delamination and considered as noise.

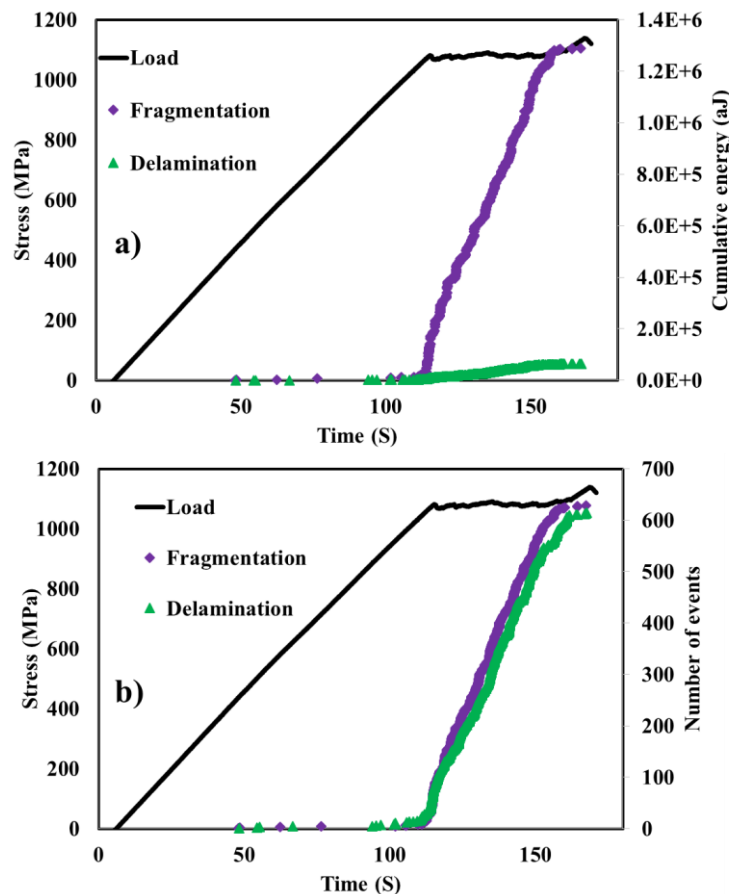
Figure 4. The cumulative of a) AE event energy and b) number of the AE events in each class of the AE signals for a typical 2TR30/S-glass specimen with two carbon plies [9].

The cumulative AE energy and number of the AE events in each class of signals are illustrated in Figure 4, for a typical TR30/S-glass specimen. Fragmentation associated signals have much higher cumulative energy compared with the delamination associated ones. It can be seen from Figure 3a and Figure 4 that the signals related to fragmentation appear near the plateau in the stress-time diagram and they are well separated from those related to delamination.

In addition, it is possible to count the number of failures in each class based on the number of AE events that hit the sensor. An AE event is the phenomenon which releases elastic energy in the laminate, which then propagates as an elastic wave. In this case, the mechanisms were either fragmentation or delamination and each AE signal can be regarded as a separate damage event. The number of fragmentation events prior to final failure is 628 and the average energy content for fragmentation is 2050 aJ. The number of AE events associated with delamination is also illustrated in the figures.

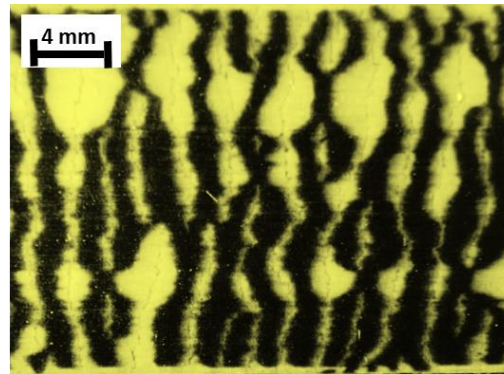
Figure 5. Microscopic images from the surface of a typical 2TR30-S-glass (Localised delaminations around multiple carbon-ply cracks)

These results are in good overall agreement with our visual inspection of the specimens and the videos captured during the tests. A low magnification microscope image obtained from the surface of the specimen is shown in Figure 5. The delaminated back surface of the glass layer blocked the visibility of the carbon. Therefore, the well bonded areas appear black, and within the locally delaminated light areas, the cracks in the carbon layer are visible as sharp bright lines. From our observation during the tests and as illustrated in Figure 4, fragmentation and delamination occur concurrently and are the origin of most of the AE signals.
