# COMPARATIVE ANALYSIS OF IN-PLANE AND OUT-OF-PLANE MECHANICAL BEHAVIOUR OF SPOT-WELDED AND MECHANICALLY FASTENED JOINTS IN THERMOPLASTIC COMPOSITES

**Keywords:** Thermoplastic composites, spot-welded joint, mechanical behaviour, fracture analysis

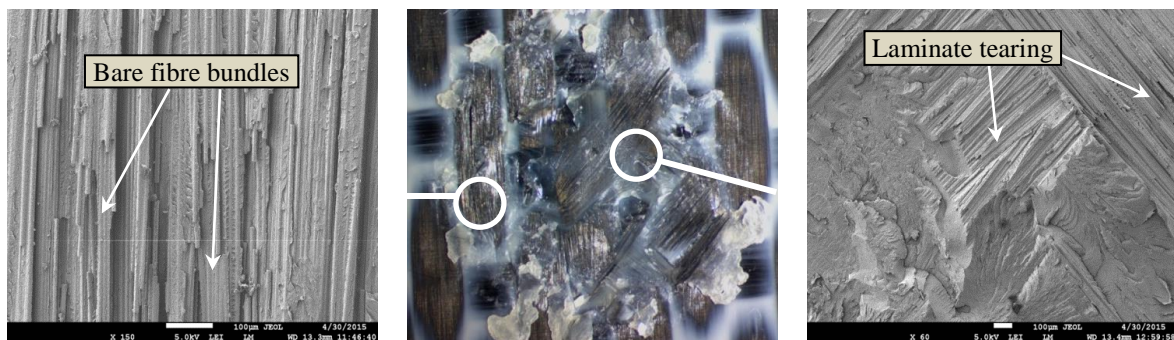
**Figure 9.** Fracture surface of the spot-welded joint after PT tests (middle). The left and right images show SEM details for the failure modes, indicated by the left and right white circles on the fracture

surface, respectively. Welding parameters: energy 600 J, welding force 1500 N, peak-to-peak amplitude 60.8  $\mu\text{m}$ .

Similar to the observation in DLS tests, the visual inspection on welded samples after PT tests reports that a circular welded joint (approximately 9 mm in diameter) presents on the central point of overlap (Fig. 9) and no further failure appears on the sample surface. Meanwhile, SEM analysis indicates that intralaminar failure, consisting of fibre-matrix debonding and laminate tearing, is still the major failure modes for welded joints. As a comparison, bending failure happens on the bottom substrate of mechanically fastened specimens due to the penetration of the Hi-Lok<sup>TM</sup> collar during tests (Fig. 10). Cracks are found radially propagating away from the bolted hole and thus leading to a significant size of damaged zone in the substrates [8].
