## REPAIR PROCEDURE ON VEGA SRM SKIRT

The aim of the present work is to present a repair procedure for composite skirt of VEGA Solid Rocket Motors (SRM), validated on scaled cylinder representative of the Skirt of the P80-SRM.

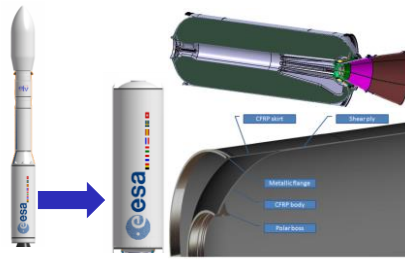
**Figure 1:** SRM case architecture.

VEGA LV is currently equipped with 3 SRMs and the biggest one is currently the P80, which is shown in picture below.

The SRM composite structural Case can be schematized as a cylindrical pressure vessel with ending domes which mainly sustains the internal pressure, due to propellant combustion, and two cylindrical Skirts, connecting the SRM to the adjacent stages, which have to sustain quite high compressive loading due to Launch Vehicle maneuver, external aerodynamic and SRM thrust.

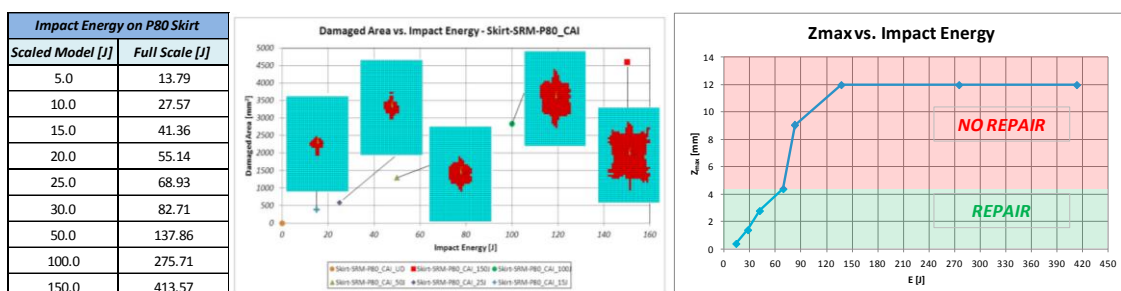
**Figure 2.** Relation between scaled and full-scale impact energy. Damaged Area on scaled thickness flat panel. Damage depth on full thickness flat panel.

Explicit numerical analysis were performed with Ls-Dyna code in order to estimate the energy threshold of an impact event. Figure 2 shows the relation between the impact energy relative to the scaled panel and the full-scale panel, the damaged area on the scaled panel and the damage depth on the full-scale panel in function of impact energy level. The analyzed impact energy level ranges from 5J to 150J on scaled model, corresponding to 14J and 414J on full-scale model, respectively.

It is possible to note that the energy threshold is 25J (69J), since over this value, the damage depth is greater than 1/3 of the total thickness.

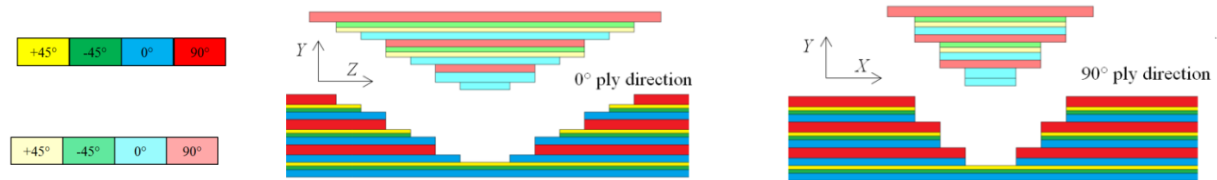
**Figure 3.** P80 Skirt repair schema

The most important parameter at this phase is the overlap length between the damaged and repair layer: adequate load transfer shall occur, in shear mode, at the interface between the damaged 0° and the 0° repair layers. Such length has to be as small as possible in order to limit repair dimensions but long enough to produce acceptable shear stress peaks.

The patch design proposed for the repair of the P80 Skirt is shown in Figure 3.

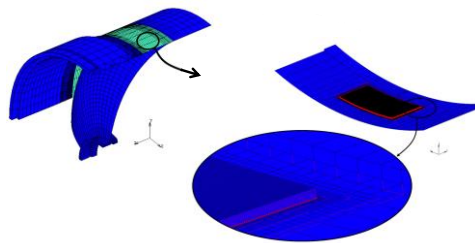
**Figure 4.** Global-Local models used for the numerical analysis

1. A global FE model validated in the frame of VEGA program is used to determine global stress distribution in SRM skirt location; modelling details are reported in [3].
2. A local FEM simulating the patch geometry is implemented to get detailed stress distribution in any ply of the patch (see Figure 4). The local was a layer-wise model where each single layer was discretized through eight brick elements; Global model shell displacements and rotations are reported to 3D section by means of RBE2. In such model in order to limit the number of the degree of freedom, the length L (see Figure 5) had been set to 5mm; such value should be extended to 20mm in real application.

The repair scheme was implemented on the P80 finite element model (Figure 5), developed in MSC Marc and validated in VEGA program, to verify interfaces shear stress and lamina stresses distribution. A Global local approach was:

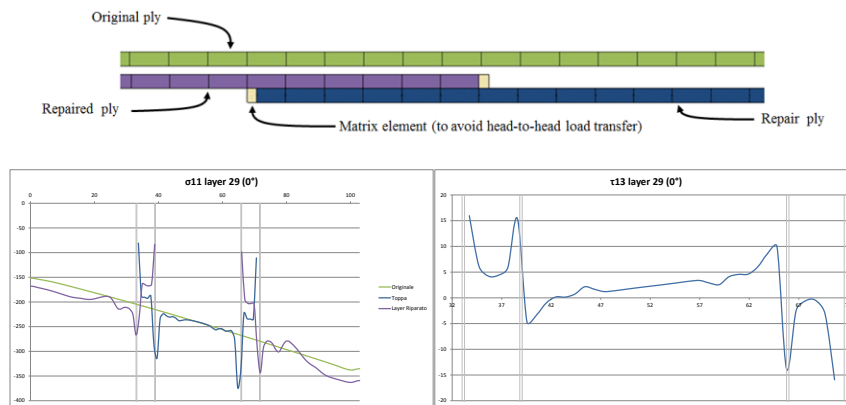
**Figure 6.** Fiber load and interface shear stress distribution for the most critical layer in the P80 SRM repaired skirt

Due to the buckling-like deformation of the skirt under external loading, the maximum compression stress, due to bending, arises in the outer 0° ply. Results are reported in Figure 6.

Simulation shear stress distributions results are in good agreement with the analytical prediction, in terms of peaks values: positive Margin of safety, in terms of interlaminar stress and lamina stress, are guaranteed. Repair fibers also tend to be loaded like the corresponding original ones; peak values arise at the overlap ends. In conclusion, the numerical evaluation has shown that the repair patch is reliable.

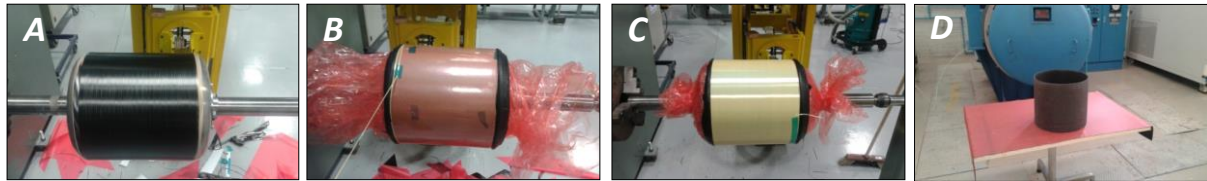
**Figure 7.** Filament winding of the hoop layers (A), Release film (B) and Kevlar winding (C), Undamaged Cylinder (D)

The two Cylinders were manufactured using Filament Winding process for the plies 90° (hoop) and hand layup for the plies 0° (Figure 7 A) and ±45° .

The cure of the item was carried out in autoclave without added pressure. To compensate for the absence of pressure during the cure cycle, the two external layers in Kevlar were applied as hoop layers. Of Course, in order to separate the Kevlar from the CRFP item, the porous peel ply and release film were applied (Figure 7 B, C).

After the cure, the cylinders were trimmed and prepared for the mechanical test (for the reference undamaged cylinder) and for repairing procedures (for cylinder to be repaired) (Figure 7 D).

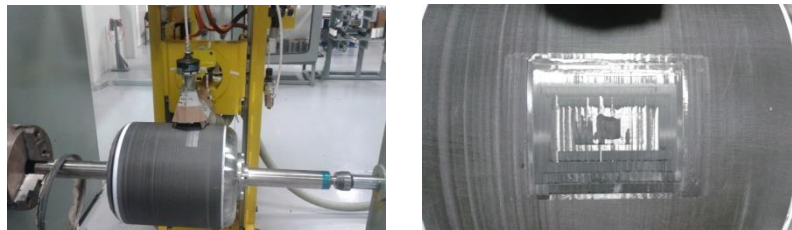
**Figure 8.** Stepped scarfing phase

As far as the scarfing, it was performed using a pneumatic cutter applied to the Filament Winding machine, in order to work with only four degrees of freedom, including the rotation of the mandrel.

Removing a single layer was a challenge aspect, because it needs a very high accuracy of the “z axis” machine and high geometric precision of the item. Figure 8 shows the imperfection of the scarf due to reason said previously. In this case, the scarf was hand-optimized.

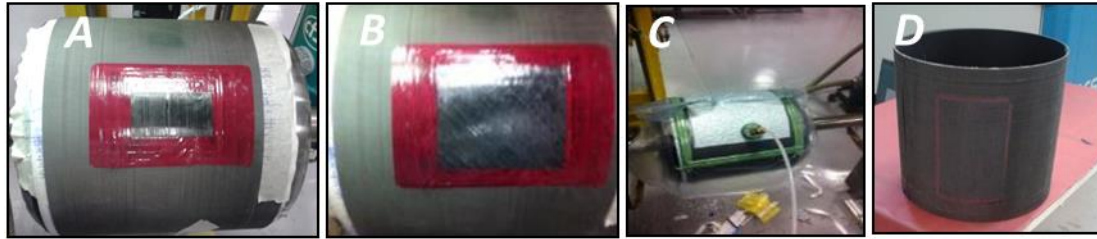
**Figure 9.** Hand lay-up of the repairing patch, vacuum bag and repaired scaled cylinder Skirt

The novel Tape prepreg was used to laminate the repairing patches by hand layup process. On the scarfed surface of the cylinder, an adhesive film (3M scotch weld, TMAf163/2) was applied, with the aim to ensure the adhesion between the repairing patch and the scarf on the cylinder. Then the plies of novel tape prepreg were cut and applied according to designed dimensions and orientations (Figure 9 A, B).

The vacuum bag was applied directly on the surface of the Cylinder (Figure 9 C). The cure cycle was optimized for the resin developed in the project. Figure 9 D shows the final repaired cylinder after the cure and trimming processes.

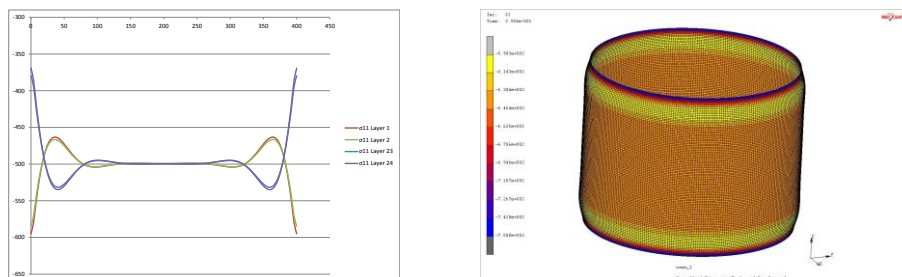
**Figure 10.**  $\sigma_{11}$  in inner and outer  $0^\circ$  ply and failure elements at 1140 kN

The stress component  $\sigma_{11}$  (fiber direction) is plotted in the internal and more external  $0^\circ$  cylinder laminas and reported in Figure 10.

The external compressive load at collapse is expected to be at least 2124 kN in case of defects absence, but the material used for the manufacturing, showed a lower compression strength [2]. Using updated allowables, based upon new experimental data performed on same batch material used to realize the scaled skirt, the expected collapse load was evaluated equal to 1140 kN.

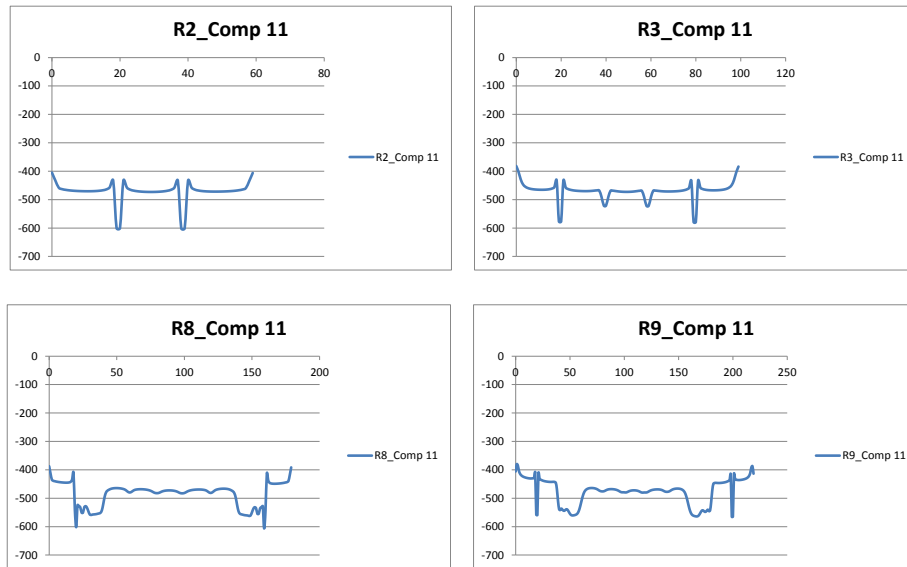
**Figure 11.**  $\sigma_{11}$  stress [MPa] in  $0^\circ$  Repair laminas

Figure 11 shows the  $\sigma_{11}$  stress distribution in the repair layers at  $0^\circ$ : R2, R3, R8 and R9. The maximum stress is always below allowable value.

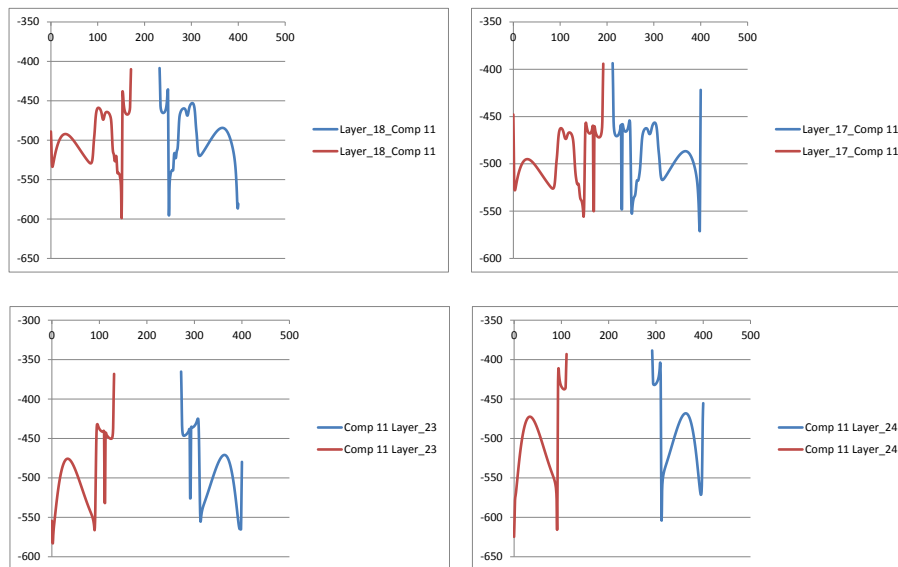
**Figure 12.**  $\sigma_{11}$  stress [MPa] in  $0^\circ$  original plies

In Figure 12 the stress level in the original  $0^\circ$  layers is reported; the allowable compressive strength was not exceeded in any location.

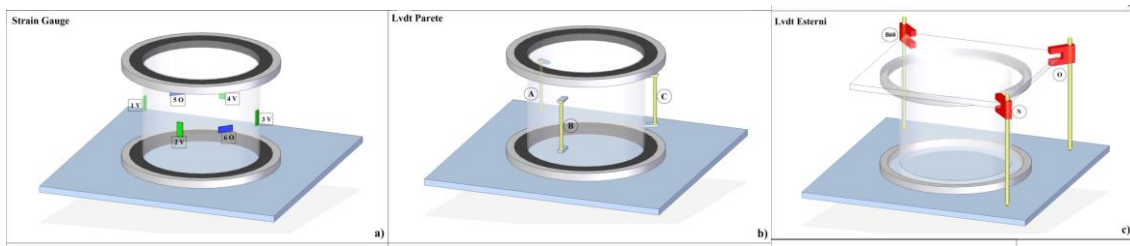
**Figure 13.** Strain gauges and LVDT locations

- Six LVDT (3 fixed on the rigid plates used to introduce the load, and 3 on the external layer of the cylinder (Figure 13 b, c)
- Six strain gauges (4 in axial direction, spaced of  $45^\circ$  each other; and 2 in tangential direction, stepped of  $180^\circ$  each other) (Figure 13, a).

For the repaired cylinder, both the two strain gauges (axial and tangential) and a LVDT were placed in the patch zone.

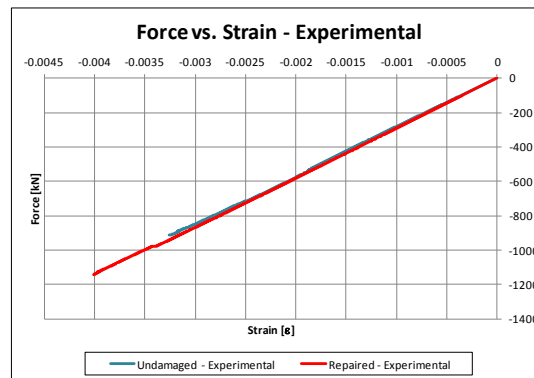
**Figure 14.** experimental compression test: load vs. applied strain curve

Figure 14 shows the load vs. applied strain curve for undamaged and repaired structure. The maximum load reached for the undamaged cylinder was 914 kN, while the maximum load reached for the repaired test case was 1144 kN. The premature failure of the undamaged cylinder could be addressed to a not perfect parallelism of the two ends. In fact, after the failure, the damages were not equally distributed around the potting zone. Instead, the repaired cylinder ends were perfectly flatness and parallel. The experimental failure load is in excellent agreement with the estimated failure load.

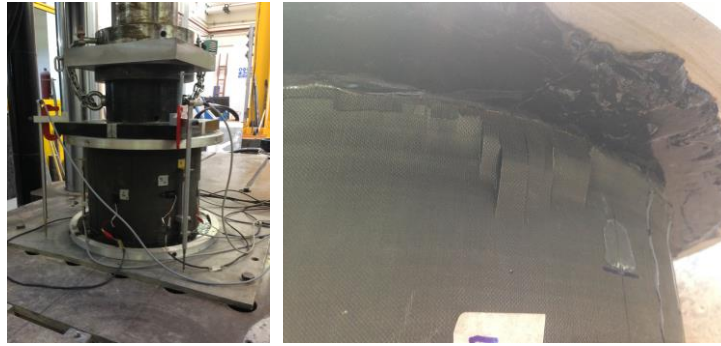
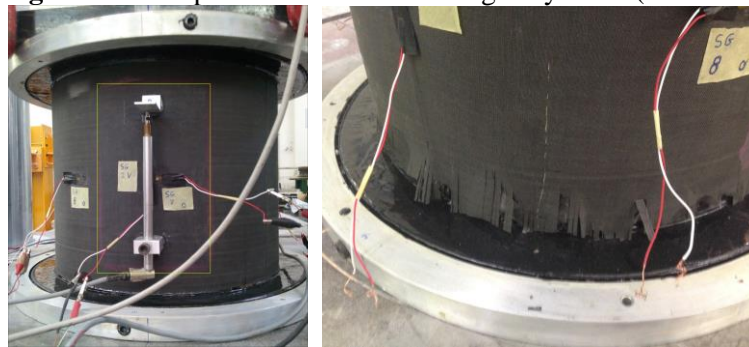
Figure 15 and Figure 16 show both cylinders before and after test, respectively. It is possible to note that both test articles failed at the same way. The inner and outer lamina, close to the potting zone, collapsed probably due to delamination and successive buckling induced by the high stresses in the constrained zone. After their failure, the remaining layers cannot support the load and so the entire structure collapsed. The repaired zone did not show any failure.

**Figure 15.** Compression Test of undamaged cylinder (reference)

**Figure 16.** Compression Test of repaired cylinder

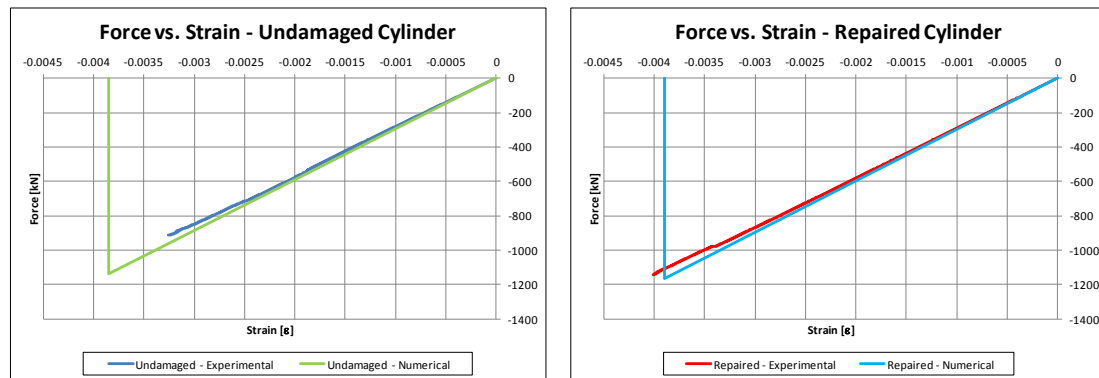
**Figure 17.** Comparison between numerical and experimental results

Figure 17 shows the comparison between numerical and experimental results both for undamaged and repaired cylinder.

The difference between numerical and experimental results are negligible for the repaired case, while are about 24% for undamaged case. However, this is not reliable; certainly, the experimental result is smaller than the numerical for the reason explained previously. More investigation will be performed using further experimental tests.
