NUMERICAL AND EXPERIMENTAL INVESTIGATION INTO THE INFLUENCE OF GEOMETRIC PARAMETERS OF HYBRID COMPOSITE REPAIRS ON MECHANICAL PERFORMANCE

Keywords: composite repair, co-bonded joint, hybrid joint, reinforcing yarn

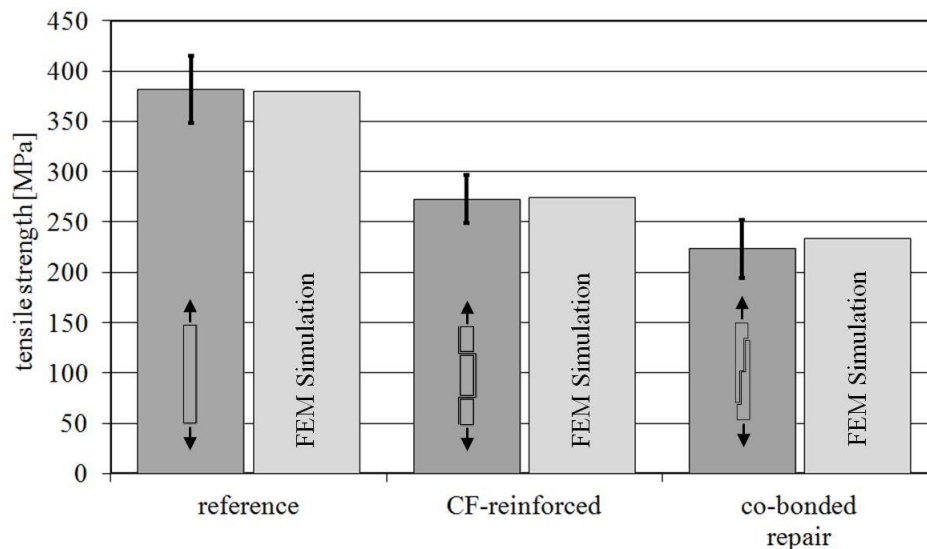
Figure 6: Tensile joint strength of GFRP-laminates (cp. [5]).

The FEM idealizations show very good agreement with experimental results. In Figure 6, one example for a GFRP parent component is illustrated (see [5] for further validation data).

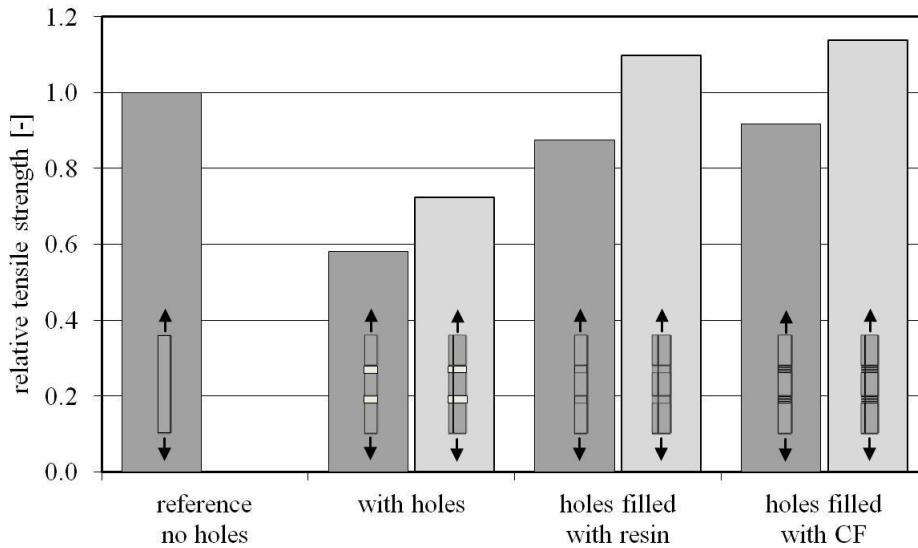
Figure 7: Strength of parent material (reference) compared to parent materials weakened by bore holes filled differently based on simulations.

In order to estimate the potential to restore the tensile strength, we first investigate the influence of bore holes on the parent structure. I.e. the strength reduction due to the introduction of drilled holes is determined based on the described Finite Element modeling. In comparison to the yarn idealization according to section before, the yarn is modeled here as ideal-elastic orthotropic continuum without any failure behaviour. In Figure 7, the parent material is indicated as reference with no holes. This reference is compared to two different parent materials, first, to one which has the same layer set-up but different hole combinations (dark grey) and secondly to a parent material which is doubled by the overlap that occurs in the repair (cp. Figure 1). The latter one is consequently thicker by $t = 0.53$ mm than the parent component of the repair. The hole combinations comprise parent material with holes that are not filled, holes filled with resin as well as with carbon fibre (CF) yarn. Figure 7 clearly indicates that the strength reduction due to the drilling of bore holes can be compensated to a certain value by filling the hole by CF yarns. If the parent material is not doubled in thickness by the overlap, the limit is possibly about 90-92 % of the strength of the parent material. If a thickness enlargement is allowed as possible by the repair under investigation here, then a strength restoration of up to 100 % seems likely.

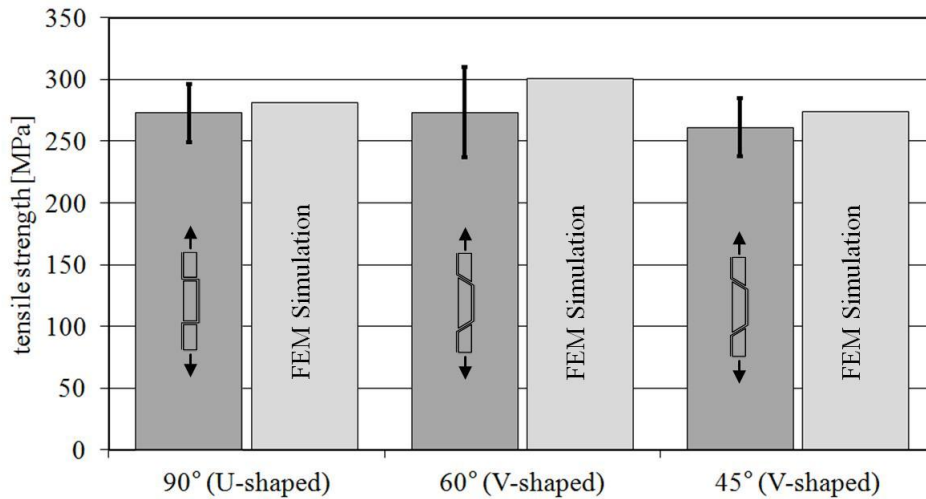
Figure 8: Strength of specimens with different bore hole angles (bonding area is reinforced with carbon fibre yarn) based on experiments and FEM simulations.

In Figure 8, the tensile strength is compared between repair specimens with different bore hole angles of the reinforcing yarn. A carbon fibre yarn is used to reinforce the bonding area. The experimental investigations as well as the Finite Element simulations do not show a clear influence pattern as well as a clear performance improvement. This is possibly due to the highly nonlinear impact of the bore

hole angle on the mechanical behavior. The nonlinear influence is caused by the selected layer set-up, the number of steps in the repair, the material of the reinforcing yarn and the position of the bore holes among others. Due to this complexity, only bore hole angles of 90° (U-shaped and T-shaped) are considered in the following.

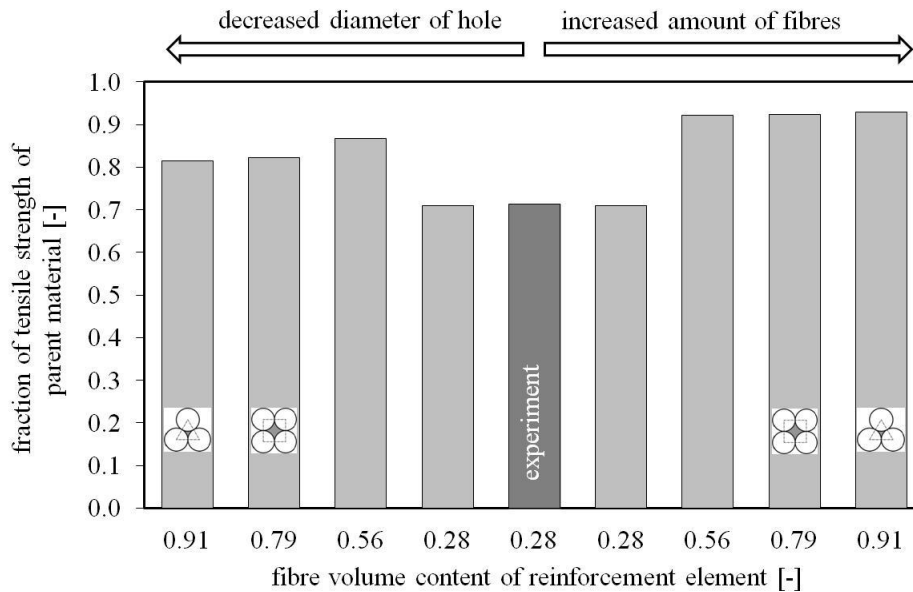
Figure 9: Influence of fibre volume content of carbon fibre yarn reinforcement on tensile strength.

In Figure 9, the effects of hole diameter as well as the fibre volume content of the reinforcing yarn on the strength are shown. The experimental result is shown in the middle in dark grey. The values to the left and right are simulation results. To the left, the hole diameter is decreased leading to an increased fibre volume content of the yarn. The diameter is decreased in such a way that, first, the yarn is twice as strong as the original one (28 % original fibre volume content). Then, the simulation results for theoretically possible fibre volume contents for quadratic as well as hexagonal fibre packing ($\approx 79\%$ resp. 91%) are given. To the right, the same fibre volume contents are set but now by adding additional fibre material into the unchanged hole, i.e. with constant diameter. The simulation results suggest that a reinforcement of the yarn in the holes that is twice as strong as the one used in the experiments can improve the tensile strength by about 20 % points. To summarize, as much yarn

material should be introduced into the drilled bore holes as possible. And simultaneously, the bore holes should be as small as possible.

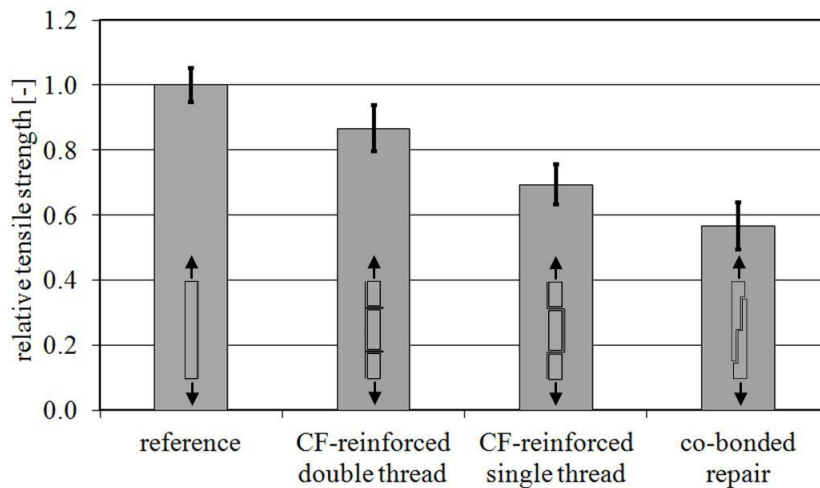
Figure 10: Influence of double thread in bore hole on tensile strength based on experiments.

In Figure 10, experimental results are given where the fibre volume content in the holes with constant diameter is increased using tufting technology. As a result, we obtain a double thread in the hole. The tensile strength is increased compared to the single thread by about 17 % points to about 87 % of the tensile strength of the parent material.
