# INVESTIGATION OF THE EFFECT OF WATER JET CUTTING AND MACHINING ON CRACK INITIATION IN OFF-AXIS TEST SPECIMENS

Jens J. Bender<sup>1</sup>, Jens A. Glud<sup>1</sup>, Esben Lindgaard<sup>1</sup>

<sup>1</sup>Aalborg University, Department of Mechanical and Manufacturing Engineering,  
Aalborg University, Fibigerstraede 16, 9220 Aalborg, Denmark  
Email: bender@m-tech.aau.dk

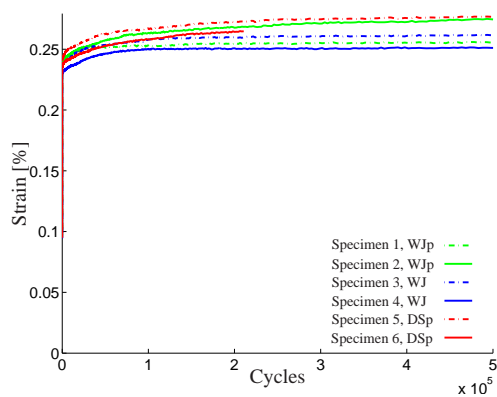
Figure 4. Strain results for all specimens.

The experiments for this paper are currently being conducted at Aalborg University, which means that the complete set of results are to be presented at the ECCM17. However, a preview of the results and the complications with obtaining accurate results are included in this paper in Fig. 4 and 5. It is verified manually that the algorithm has counted the visible cracks correctly for all specimens except specimen 1.

There are variations in the saturated strain levels for the tested specimens as shown in Fig. 4 and this can be seen to have an effect on the crack density in Fig. 5. However, based on the preliminary results presented here it would seem that the specimens cut with water jet cutting and polished afterwards tend to exhibit lower crack densities than the other specimens. This could on the other hand be due to the fact that these specimens were tested without any kind of reduction in the dynamic range and therefore cracks in the stitching areas are difficult to detect. For the specimens where the dynamic range was decreased it came apparent that cracks generally initiated earlier in the stitching than in the rest of the specimens. Hence, this could be one of the reasons why the crack density of these water cut and polished specimens is lower than for the rest of the specimens. The crack density in specimen 1 and 2 is still lower than in the other specimens if it is assumed that there are cracks in all the stitching from one edge to the other in specimen 1 and 2 provided that the saturated strain level is considered as well.

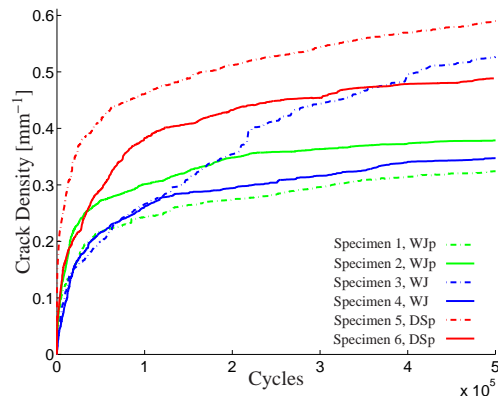
Figure 5. Crack density for all specimens.
