THERMAL AND REACTION TO FIRE PROPERTIES OF CFRP UNDER VARIOUS HEAT IMPACT SCENARIOS -SPECIFIC HAZARDS

Abstract

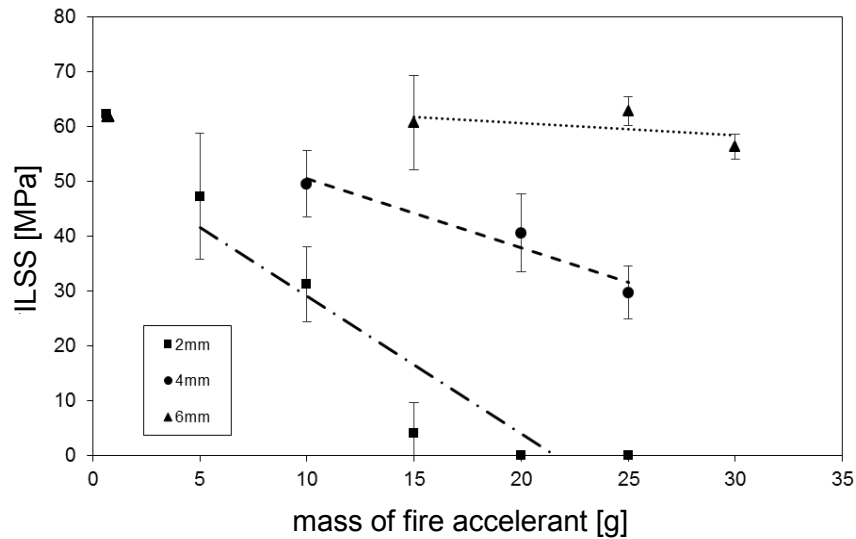
Figure 3. Residual Interlaminar shear strength (ILSS) in the center of various thick, horizontally positioned 100 x 100 mm² panels after application of various amounts of a fire accelerant

Laboratory scale tests with fire accelerants show a significant loss of residual strength dependent on the amount of fire accelerant and the thickness of the $100 \times 100 \text{ mm}^2$ -panels (Figure 3). For 2 mm thick panels, 15 g of the fire accelerant are sufficient for a nearly complete loss of the panels' mechanical integrity, whereas 6 mm panels retain about 80% of their initial strength. Combustion of the polymer matrix leads to a relative mass loss of max. 5% for the 2 mm panels and 1% for the 6 mm panels, which does not significantly contribute to the heat release of the fire accelerant [10]. Damaged areas indicated by delaminations increasingly penetrate the material with increasing amounts of fire accelerant. Temperatures on the backside of the panel reach maximum values of 350°C for 2 mm thick samples and ca. 260°C for 6 mm thick samples. Front side temperatures are assumed to be beyond 400°C , typically necessary for ignition [10]. Therefore, thin panels and sandwich structures are prone to failure due to the impact of improvised fire accelerants. When 500 ml of a fire accelerant is applied on an aircraft sandwich structure (see Fig. 4), severe damage is observed. After combustion lasting several minutes, the top CFRP layer is delaminated and detached from the honeycomb core. At the backside no delaminations are observed.

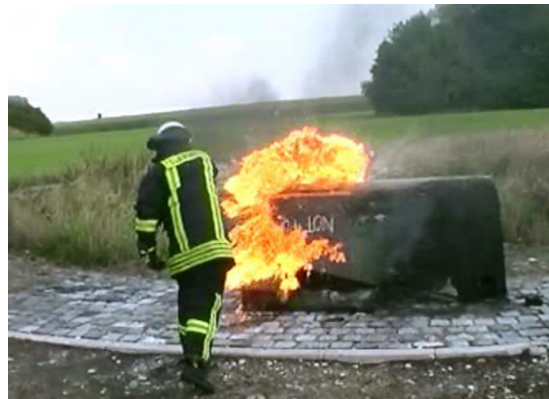
Figure 4. Helicopter CFRP sandwich structure during application of improvised fire accelerant
