EFFECT OF REPAIR DESIGN AND SURFACE TREATMENT ON ADHESIVELY BONDED COMPOSITE REPAIRS

F. Röper¹, M. Wolfahrt², G. Kucher³, A. Bubestinger⁴ and G. Pinter⁵

Keywords: composite repair, adhesive bonding, surface treatment, epoxy resin, carbon fiber

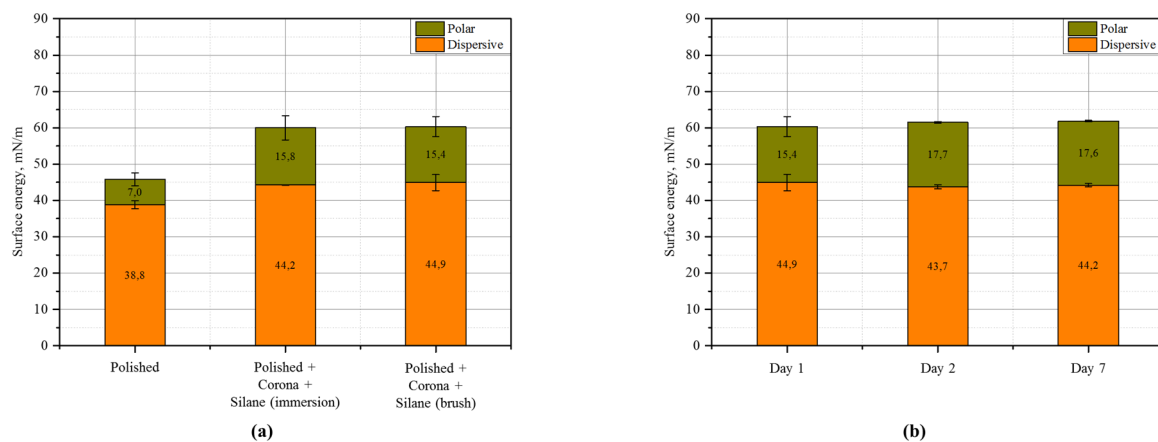
Figure 2. Surface energy for polished and functionalized surfaces (a) and surface energy of functionalized surfaces as a function of time (b).

Contact angle measurements and the resulting surface energy depicted in Fig. 2 (a) show that through the surface functionalization by corona and subsequent wet chemical treatment with epoxysilane, the total surface energy (consisting of the polar and the dispersive part) can be raised in comparison to the untreated, polished samples. Especially the polar part of the surface energy is increased by the treatment, regardless whether the epoxysilane was applied by immersion or by a brush. This is important for an actual repair process, since not all parts can be immersed in a chemical agent. Figure 2 (b) shows the surface energy as a function of time for the functionalized surfaces. It can be observed that the total surface energy as well as the ratio of polar and dispersive parts remain relatively stable for at least one week. This is in accordance with previous findings [7] and with the timeframe from the end of the surface functionalization to the start of the repair process involved in the repair-specimen production.

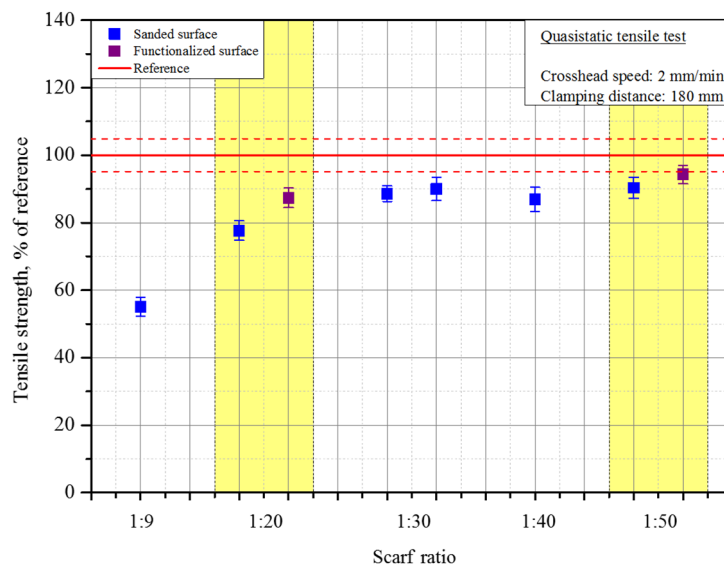
Figure 3. Repair-specimens' relative tensile strength as a function of scarf ratios for the supported adhesive and both surface preparation methods (sanding and chemical functionalization) [9].

Figure 3 and Fig. 4, respectively, show the mean relative tensile strength (normalized to the reference's tensile strength) of the repair specimens with sanded and chemically modified surfaces as a function of the scarf ratio for the supported and the unsupported adhesive. In terms of better visibility, the repair-specimens with functionalized surfaces as well as their corresponding counterparts with identical scarf ratios and sanded surfaces, and additionally the reference specimens' tensile strength are highlighted. Specimens with scarf ratios of 1:30 were produced from two different repaired plates for each type of adhesive, with the intention of investigating the reproducibility of the repair process itself (see also Table 1). As depicted in Fig. 3 and Fig. 4, no significant changes in relative tensile strength exist for

these specimens, indicating a stable repair process. On the one hand, for scarf ratios of 1:20 to 1:50, no significant impact of the variation in scarf ratio on the relative tensile strength can be found in neither the supported nor the unsupported adhesive, when taking into account the standard deviations. On the other hand, no significant influence of the surface functionalization could be detected, which could be related to the shallow scarf angles resulting in tensile failure in the parent, the scarf or the repair laminate region rather than in the vicinity of the bonded surfaces (cohesive or adhesive failure). For the scarf ratio of 1:9, a significant reduction in relative tensile strength to ~55 % as well as a failure mode transition to a cohesive failure can be observed, which could be attributed to the steeper scarf angle of approximately 6°. A scarf angle dependent transition in fracture mode was also found by e.g. Twist et al. [16] for a quasi-isotropic laminate using a hard patch repair approach.

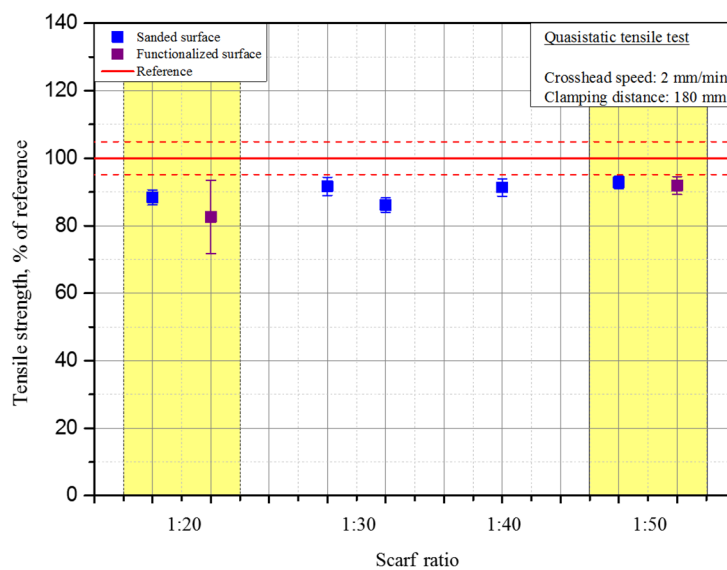
Figure 4. Repair-specimens' relative tensile strength as a function of scarf ratios for the unsupported adhesive and both surface preparation methods (sanding and chemical functionalization).
