# NON-LINEAR RESPONSE OF ENVIRONMENTALLY AGED POLYMER COMPOSITES: A PHYSICO-CHEMICAL AND MECHANICAL STUDY

This paper presents a complete characterization study on the response of FRPs to hygrothermal (or hot/wet) aging. The work is part of the EPSRC funded Duracomp project (EP/K026925/1). The analysis of the long-term properties of the FRPs in a reasonable time-frame was achieved by exposing specimens in short-term hot/wet aging for 112 days. The induced degradation was assessed by a complementary study which involved moisture uptake tests, mechanical testing, inherent and micrographic examinations such as Computed Tomography (CT-scanning) and Scanning Electron Microscopy (SEM). Impedance spectroscopy was used as an innovative technique to efficiently monitor hygrothermal aging. This work is expected to strengthen the knowledge and overall understanding of the (non-linear) behaviour of FRPs when exposed to extreme service conditions.

The work was conducted on a commercially available pultruded glass FRP (GFRP) flat sheet (FS040.101.096A, Series 1500 (I)) supplied by Creative Pultrusions Inc. (<http://www.creativepultrusions.com/>). It consists of a 5-layer polyester matrix lamina

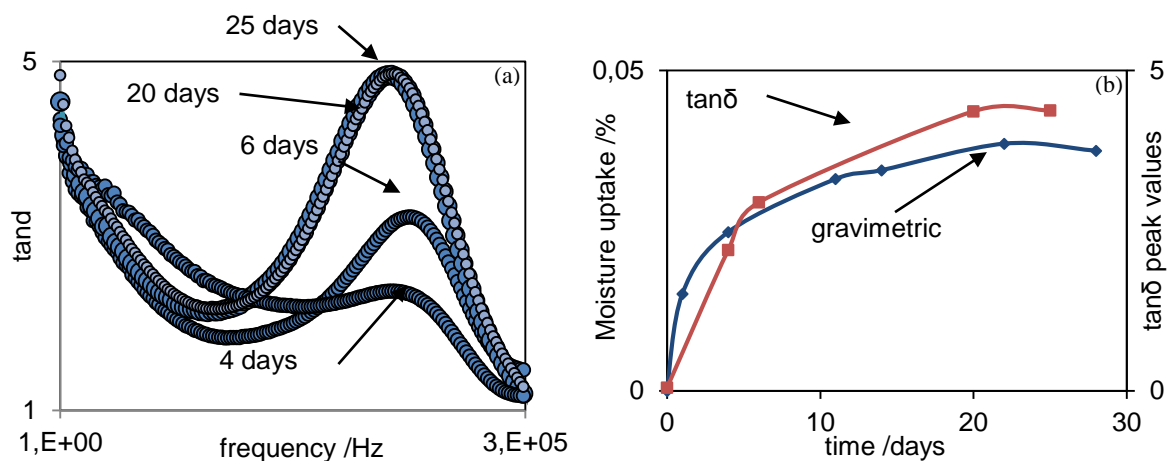
Finally, changes of the material's dielectric properties were captured with a view to monitoring the moisture absorption process. Frequency sweep scans were performed in a range of 1Hz to 10MHz. For this test, the specimens were continuously immersed in water at 60°C. Fig. 7a depicts the changes of  $\tan\delta$  values with aging time as a function of frequency.  $\tan\delta$  corresponds to the dielectric dissipation factor [6, 7]. As is shown in Fig. 7a, frequency sweep spectra follow a characteristic trend exhibiting a peak  $\tan\delta$  value in the frequency range of 5E-03 Hz to 1E-04 Hz. The max  $\tan\delta$  values increase with soaking time. To that end, Fig. 7b plots the  $\tan\delta$  peak-values along with aging time juxtaposed with the actual moisture uptake curve obtained through gravimetric measurements. As it is shown in Fig. 7b, the  $\tan\delta$  peak-values curve coincides with the moisture uptake curve providing a very promising estimation of moisture absorption behaviour.

**Figure 7.** (a)  $\log(\tan\delta)$  vs.  $\log(\text{frequency})$ , (b) moisture uptake content (%) and  $\tan\delta$  peak values vs. time.
