## CHARACTERISATION OF DEFECTS – DURABILITY RELATIONSHIPS FOR COMPLEX GEOMETRY PREPREG LAMINATES

Mark Battley, Simon Bickerton, Alex Mordasini, Abhiram Ramesh, Nathan Connell  
and Logan Dunning Beck

Centre for Advanced Composite Materials, University of Auckland  
Private Bag 92019, Auckland 1142, New Zealand  
Email: m.battley@auckland.ac.nz, Web Page: <http://www.cacm.auckland.ac.nz>

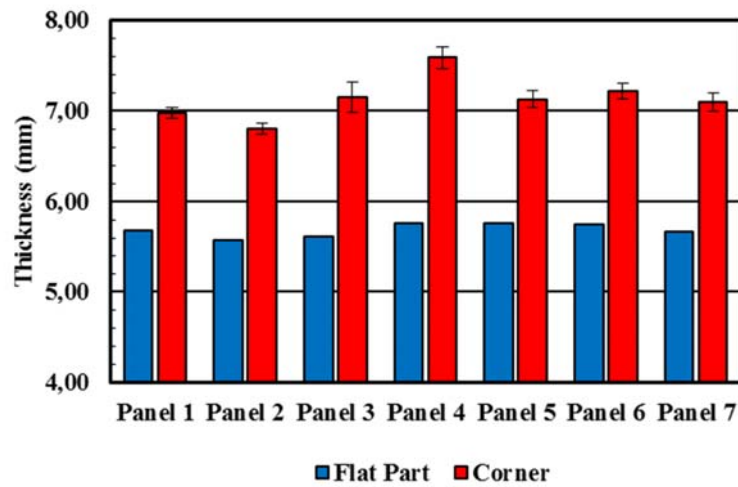
Figure 6. Specimen thickness variations.

Figure 6 displays the thickness measurement results of the seven panels. When comparing the average thickness of flat sections and corners for the different cured laminates, the corners are about 25% thicker on average. The flat parts are all similar, with an average thickness of  $5.69 \pm 0.07$  mm. Thickness variations were more significant at the corners, with 7.13 mm thickness average, and a standard deviation of  $\pm 0.24$  mm. The thickest corner was observed in panel 4 (7.58 mm), resulting in a difference of 32%, while thinnest corner is associated with panel 2 (6.80 mm), a difference of 22%. The difference in manufacturing parameters between those two panels was the bagging technique used for the debulk process, with panel 4 using a fitted bag for de-bulking and panel 2 a tubular bag.

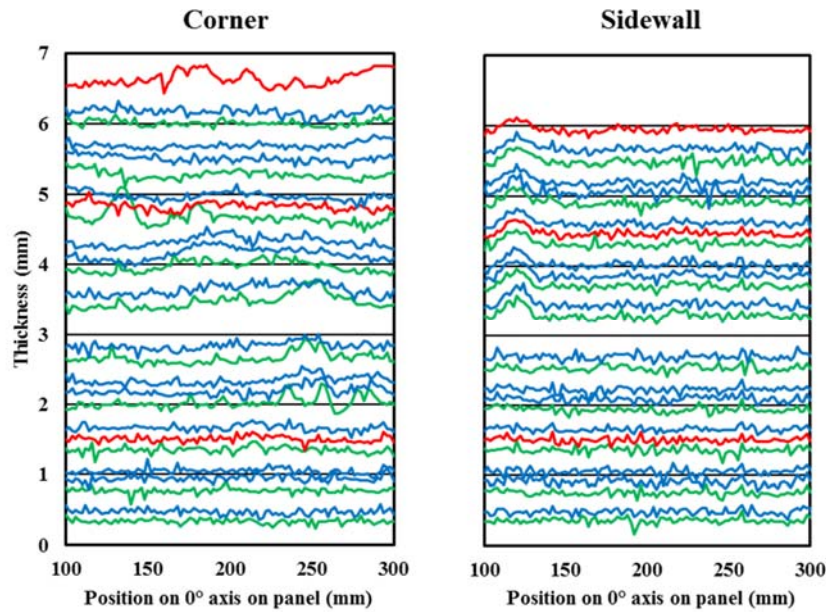
**Figure 7.** Ply stacking profile by scanning lines after debulk inside the mould on the corner and sidewall: blue lines represent 150 g/m<sup>2</sup> 90° and ±45° plies using, green lines are 300 g/m<sup>2</sup> 0° plies with 300 g/m<sup>2</sup> and red lines show last ply of the stacking sequence, highlighting the four repeats of the layup sequence.

Fig. 7 shows typical results from the thickness analysis of the layup and debulk process for the corner and sidewall laminates. Blue lines are 90° and ±45° plies and green lines represent 0° plies. Red lines show the 7th ply of each lay-up series, highlighting the four repeated stacking sequences. The red dashed line on both graphs relates to the 14th ply that is missing. This is situated at the unique place in the prepreg stack where two plies with identical orientation are laid-up in succession, enabling a single debulk process to be undertaken for those two plies.

The results enable specific behaviour to be identified, such as a 0.3 mm height wrinkle starting at the 15th ply around 125 mm on the panel axis which then impacts the following layers. Comparisons of the Corner and Sidewall graphs in Fig. 7 show significant differences in the thickness profiles. Similar results are obtained until the 8th ply, and then layer profiles dramatically change for the corner, while the side wall stays consistent. Analysis of average thickness for all scanned plies demonstrated that corner thickening could be identified at the 9th ply, and then grew proportionally as the stack is built, to end with an average difference in thickness of 0.5 mm. From Fig. 7 this appears to be related to ply 9 where ply bulges of 0.1 mm can be observed on the corner graph. These corresponded to entrapped air formed at the corner after a debulk process on a 0° ply. These kinds of surface inhomogeneity were only observed on 0° plies which also had a high standard deviation of thickness which tended to become larger as the laminate got thicker. The buckling that occurred with 0° plies may be a result of its low bending stiffness in the corner axis compared to the two other ply orientations. In general the debulk process was effective at compacting the sidewall and reducing its thickness variations, however it tended to induced variations at the corner thickness.

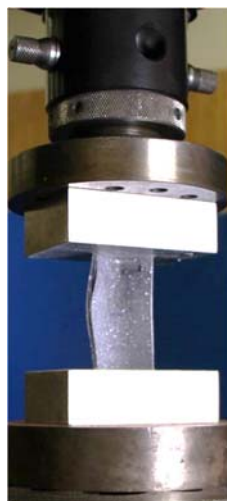
**Figure 8.** Buckling of corner compression test sample

In addition to understanding the formation of defects, an important goal of this work is to determine the criticality of the different defect types, and their effect on durability. This is being undertaken through development of test methods to characterise strength and damage progression of corner sections with defects, and modelling of the defect effects on damage initiation. Testing of corner sections is challenging, particularly avoiding end failure or edge buckling as shown in Fig. 8. Finite element modelling has been undertaken of the specimen design to develop a dog-bone configuration (Fig. 9)
