## NONDESTRUCTIVE TESTING OF COMPOSITES USING A NONLINEAR ACOUSTIC SPECTROSCOPY METHOD

**Keywords:** Nondestructive testing, Laminates, Polymer-matrix composites, Nonlinear acoustics

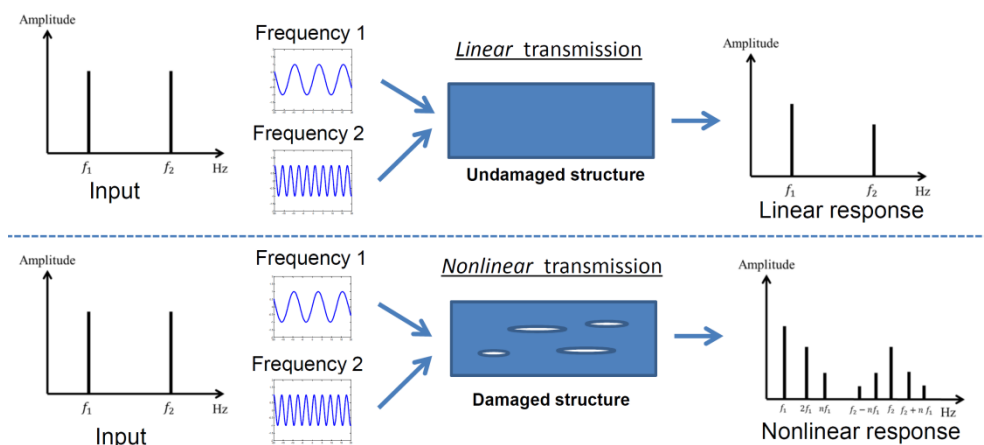
**Figure 1.** Linear and nonlinear modulation. Excitation frequencies and response of an undamaged sample with linear transmission behavior (Top) as well excitation frequencies and response of a damaged sample with nonlinear transmission behavior (Bottom).

Two general types of NEWS methods are presented in the literature [2, 5, 6]: Resonance based methods and methods that are non-resonance based. The present paper deals with the latter type of nonlinear ultrasonic spectroscopy methods that analyze the modulation spectrum. When two harmonic waves are applied with different frequencies  $f_1$  and  $f_2$  ( $f_1 < f_2$ ) in a damaged material, the amplitude of the high-frequency wave will be modulated by the low-frequency wave because of a nonlinear transmission behavior. Consequently, the created spectrum manifests a nonlinear intermodulation response by creating new frequencies such as sidebands ( $f_2 \pm nf_1$ ;  $n = 2, 3, \dots$ ) and higher harmonics ( $nf_1$ ;  $n = 1, 2, 3, \dots$ ): The damage operates like a multiplier and nonlinear mixer of the excitation frequencies. Fig. 1 illustrates schematically this phenomenon [6].

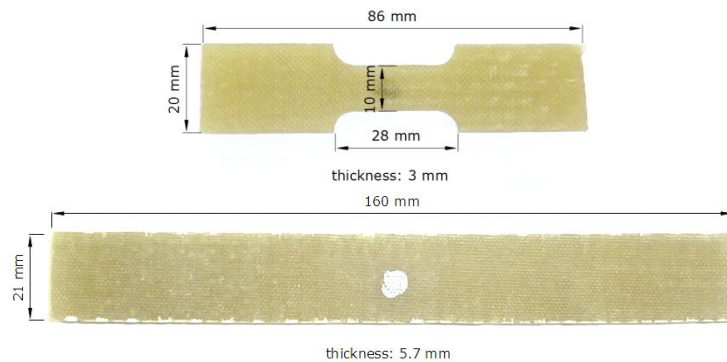
**Figure 2.** Top: Geometry of samples made of material 1 (vinylester matrix); Bottom: Geometry of samples made of material 2 (epoxy matrix).

The characteristics of the investigated materials and samples are summarized in Table 1. Each set of samples, made either of material 1 or material 2, has been prepared by application of tensile tests that are interrupted at predefined stress levels, findable also in Table 1. This allows introducing a progressive damage in the samples. Additionally, a reference sample of each set is left in the initial undamaged state. The sample's geometry of each set is detailed in Fig. 2.

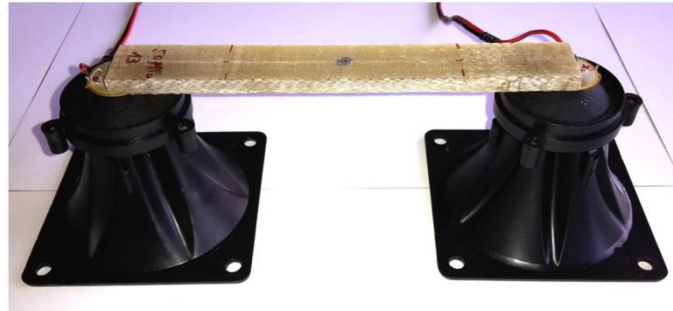
**Figure 4.** Two opened loudspeakers using the piezoelectric actuators to excite a sample in place.

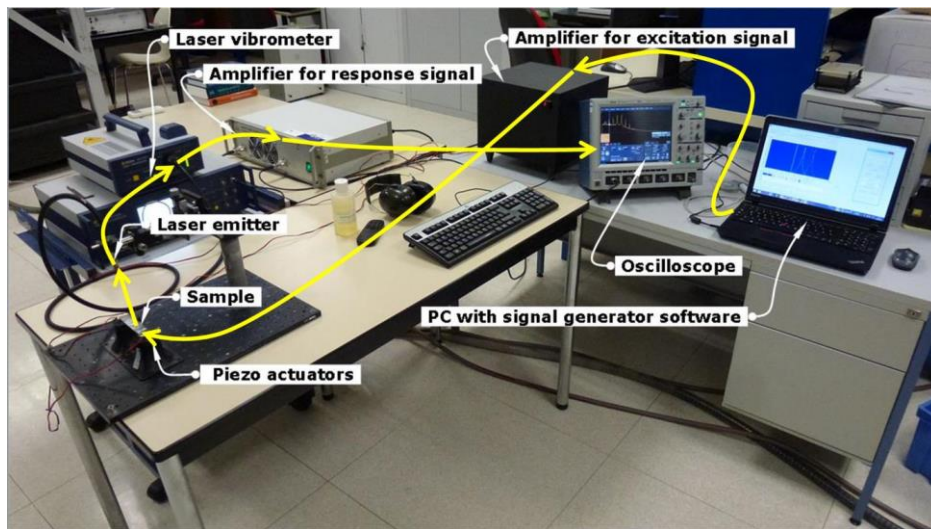
**Figure 5.** Experimental setup: Instruments are labeled and the signal paths are illustrated by yellow arrows.

The generation of the two excitation signals is provided by the sound card of a common PC using a software based signal generator. The frequencies are randomly chosen, but it has been respected that the difference between the two frequencies is smaller than the lower frequency [7]. The so generated signals are transmitted to the sound signal amplifier over the common speaker output of the PC. The generated sound-signals are then amplified and transformed into mechanical vibrations using the piezo elements of two piezoelectric loudspeakers. These are opened to place the two sample's extremities in direct contact with the piezo elements (see Fig. 4). To improve the tactile contact, an coupling gel is used. The sample's dynamic response, represented by their vibrations, is afterwards recorded by the sensor of a laser vibrometer. A second amplifier is connected to the vibrometer's output. This amplifier sends the vibration signal to an oscilloscope, which treats the signal using the Fast Fourier

Transform (FFT) to get its frequency spectrum. The experimental setup is presented in Fig. 5 including the different instruments.

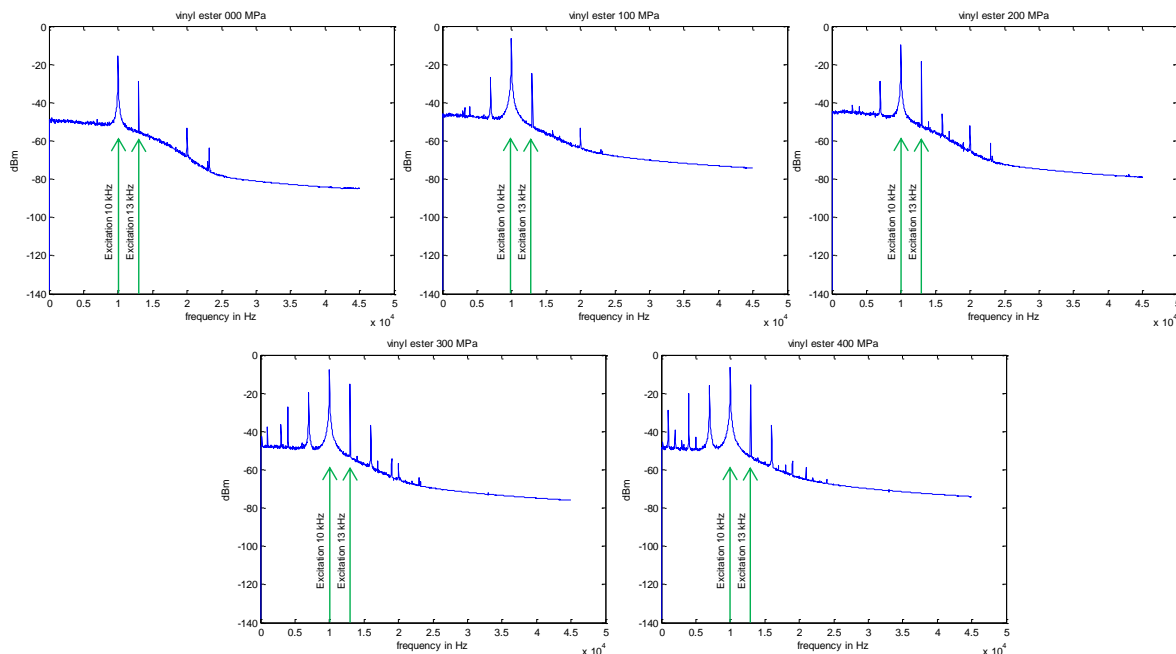
**Figure 8.** Evolution of the intermodulation with increasing damage in vinylester matrix samples excited with frequencies of 10 kHz and 13 kHz. The damage state is indicated by the corresponding applied tensile stress.

As described, increasing damage should lead to an evolution of the intermodulation products when the presented nonlinear acoustic method is applied. Exemplarily, the resultant spectra of the tests executed on the woven glass vinylester composite samples are presented in Fig. 8. Without any doubt, it can be observed that the number of peaks in the response spectrum increases with increasing damage. In the case of the undamaged sample, there are only two peaks remarkable beside the peaks resulting from the excitation indicating a nearly linear transmission behavior. The nonlinearity increases with an increase of tensile stress. This is visible by the appearance of peaks in sidebands and higher harmonics.

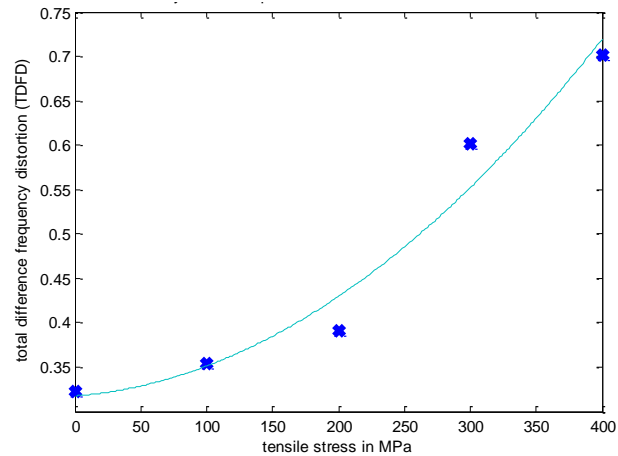
**Fig. 9** Measuring points and quadratic regression of the nonlinear transmission behavior of the woven glass vinylester composite samples under excitation of 10 kHz and 13 kHz.

The result presented as the dependence between damage and intermodulation (as consequence of nonlinear transmission behavior) is shown in Fig. 9. The Total Difference Frequency Distortion (*TDFD*) traces over the tensile stress reached to pre-damage the correspondent sample for five different cases. A quadratic regression of these measuring points is also reported and plotted to support the interpretation. An increase of the intermodulation with increasing damage is clearly visible, from  $TDFD = 0.3176$  in the case of the virgin sample to  $TDFD = 0.7014$  in the case of the maximal damaged sample.

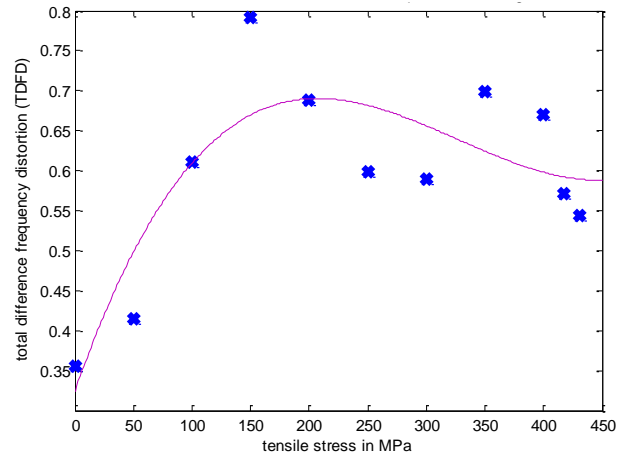
**Fig. 10** Measure of the nonlinear transmission behavior of the woven glass epoxy composite samples under excitation of 11 kHz and 14 kHz including the plot of a cubic regression.

The method is equally applied to the woven glass composite samples with an epoxy matrix using the randomly chosen excitation frequencies of 11 kHz and 14 kHz. The resultant chart is presented in Fig. 10 including a cubic regression to support the estimation of the general behavior. The chart traces the Total Difference Frequency Distortion (*TDFD*) over the tensile stress used to introduce a well-defined pre-damage in the corresponding sample for 11 different cases. With increasing damage, an increase of the parameter up to 150 MPa of tensile stress (from  $TDFD = 0.3557$  to  $TDFD = 0.7910$ ) is remarkable followed by an oscillation and even a slight decrease of the parameter with increasing damage is visible when the general behavior in this range of damage is considered. The measure of the maximal damaged sample is  $TDFD = 0.5444$ .

The described oscillation and reduction could possibly be explained by large cracks and open delaminations in the composite material. In fact, delaminations that are completely open are sources of nonlinearities particularly in their boundary zones; only in this boundary region is a contact surface that introduces nonlinear effects [9]. The parameter's oscillation is consequently justified as follows: At lower stress, small defects are created that increase the nonlinearity because of the creation of new contact areas. However, when the cracks and delaminations open and coalesce during a state of higher stress, the level of nonlinearity decreases partially. The zone of contact has been reduced. Then followed by still higher stress, new small cracks are created that start again to increase the nonlinearity up to a level till they open too. This effect is mentioned in [9] and [10] where another distortion factor has been recorded during a high cycle fatigue test of carbon fiber reinforced plastic.
